**SUMMARY REPORT
HYDRAULIC HOIST REMOVAL
ConocoPhillips Corporation**

ConocoPhillips Facility No. 256357
3323 Marine Drive NE
MARYSVILLE, WASHINGTON
DATE: February 28, 2005
SECOR PN: 01CP.06357.03

**APPENDIX A
PHOTOGRAPH LOG**

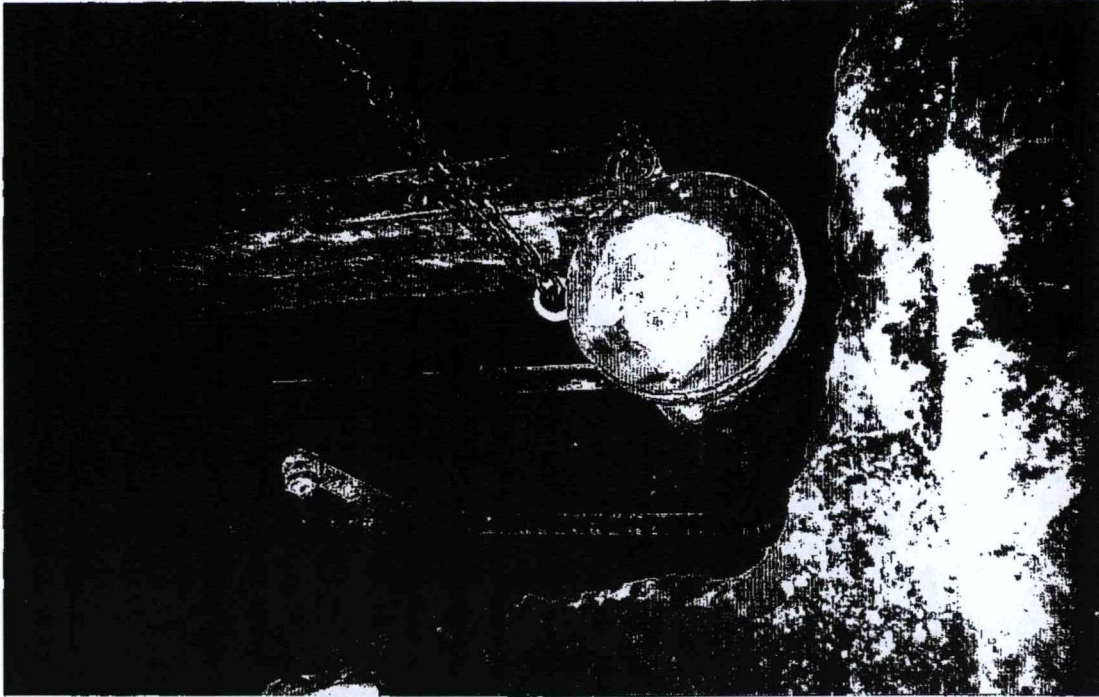
Photograph 1: Hydraulic hoist in place at north end of service bay.

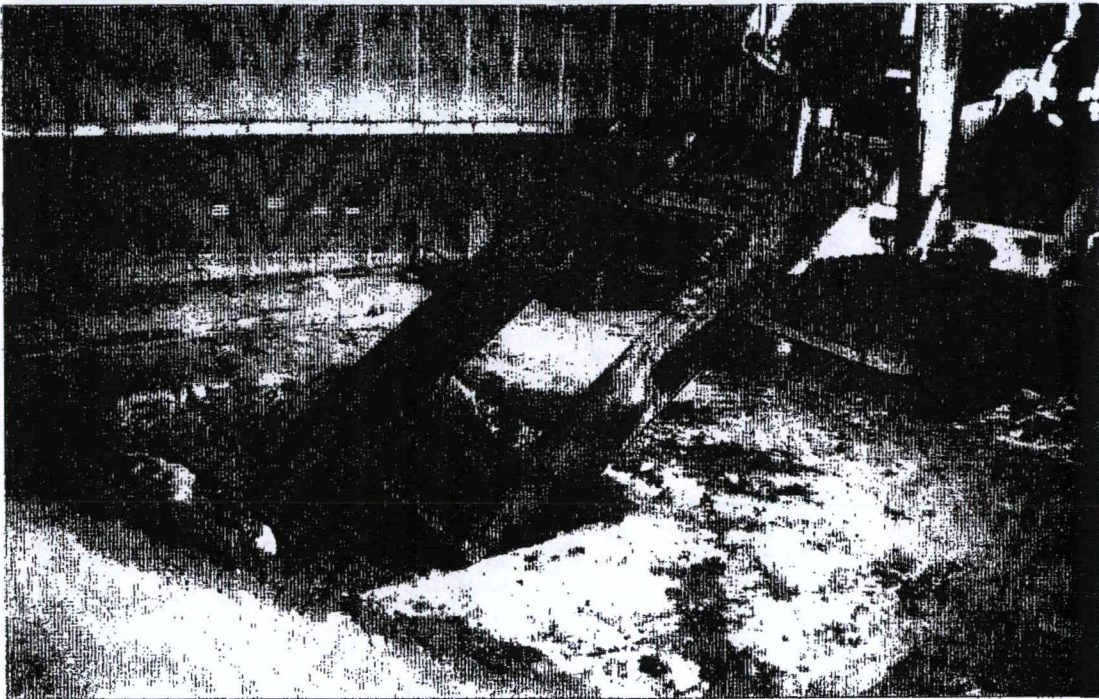
Photograph 2: Hydraulic hoist being removed from excavation with backhoe.

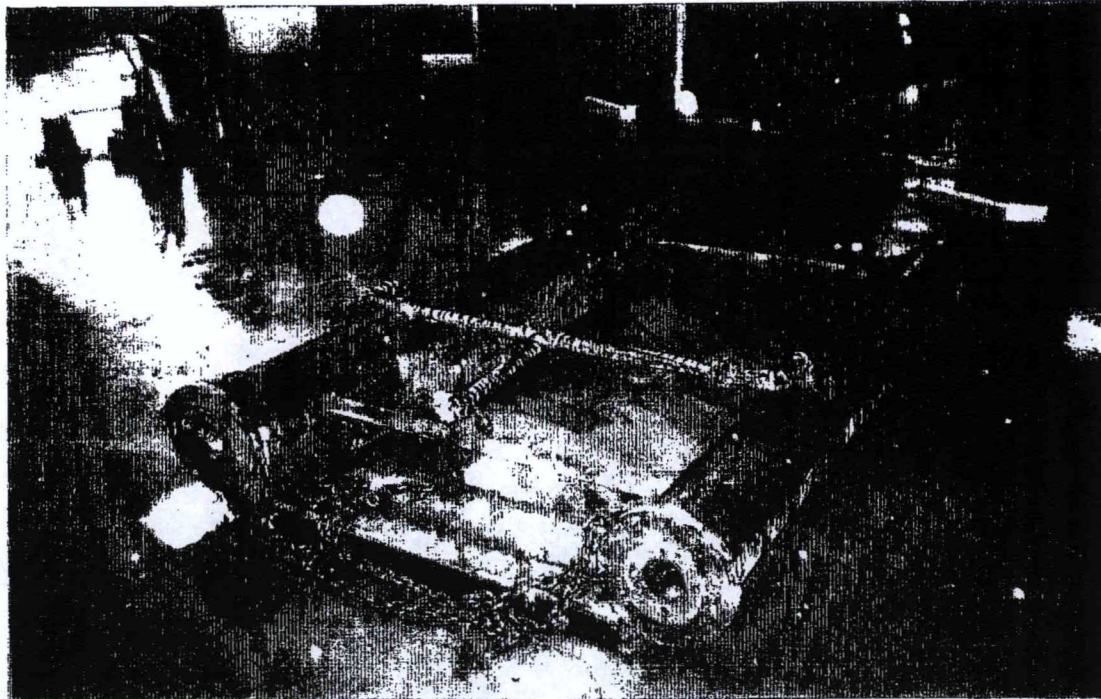
The in-ground hoist removed from Bay 3 consisted of two cylinders joined by a steel framework. Each of the cylinders measured approximately 13" in diameter and 96" in

length. The hydraulic oil tanks were contained within the bodies of the hoists. The removed hoists appeared to be in generally good condition. Minor pitting and rusting was observed on the hoist cylinders and the steel support beams.

Photograph 3: Hoist staged outside service bay for inspection.

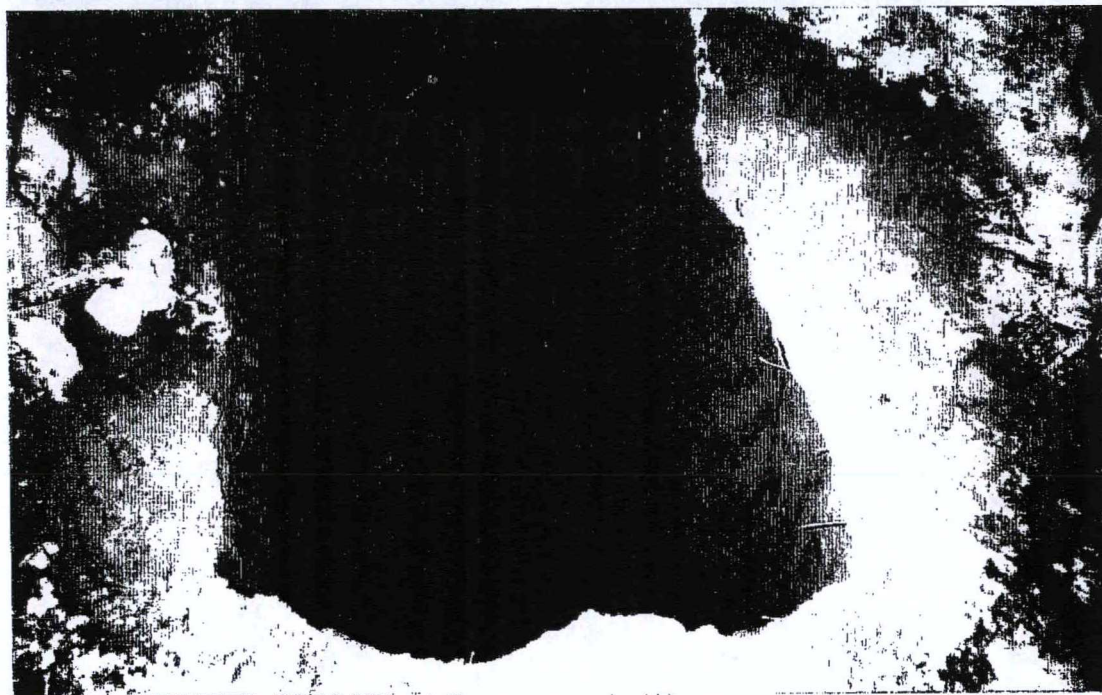
The native soils consisted of loosely-consolidated well-graded sand (SW) medium brown sand from the bottom of the concrete slab to 8 feet bgs. There was no obvious discoloration or odor evident during the excavation or sampling procedures. No groundwater was encountered.

Photograph 4: Sandy soil surrounding hoist. No groundwater encountered.
